**PRELIMINARY ASSESSMENT/
VISUAL SITE INSPECTION**

**REFLECTOR HARDWARE CORPORATION
SPACEMASTER
MELROSE PARK, ILLINOIS
ILD 005 129 457**

FINAL REPORT

Work Assignment No.	:	R05032
EPA Region	:	5
Site No.	:	ILD 005 129 457
Date Prepared	:	November 1, 1993
Contract No.	:	68-W9-006
PRC No.	:	309-R05032IL87
Prepared by	:	PRC Environmental Management, Inc. (Judy Wagner)
Contractor Project Manager	:	Shin Ahn
Telephone No.	:	(312) 856-8700
EPA Work Assignment Manager	:	Kevin Pierard
Telephone No.	:	(312) 886-4448

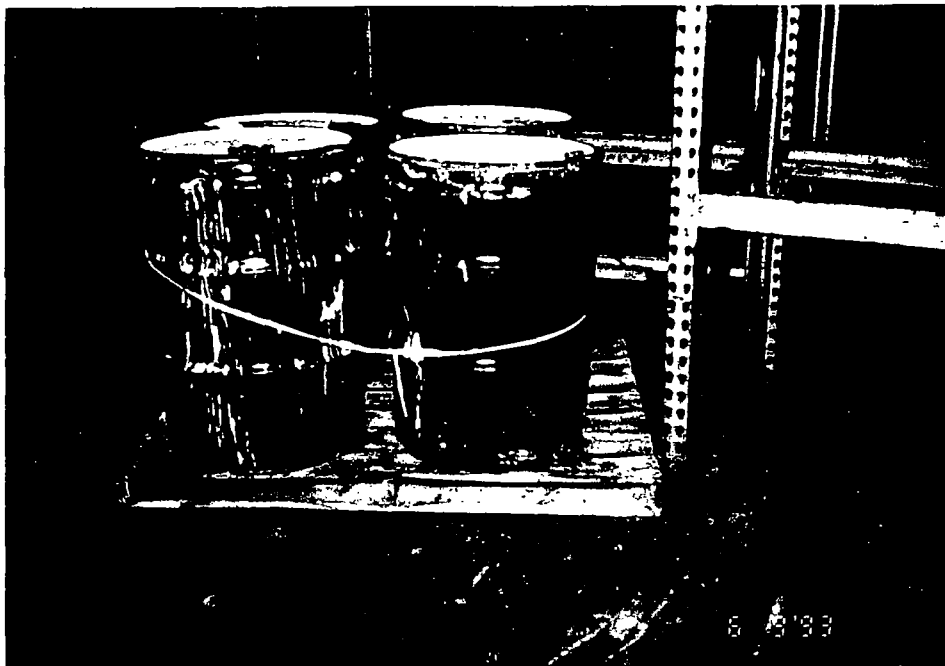
Photograph No. 1

Observations: The unit contained 32 55-gallon drums of nonhazardous waste paint sludge during the VSI. The drums were stored closed and in good condition. PRC observed small cracks in the floor. PRC observed some water on the floor (see Photograph Nos. 1 and 2). PRC noted no evidence of release.

Location: SWMU 1

Conclusions: The unit is located indoors, has an asphalt floor, and does not have floor drains. The unit now manages nonhazardous waste. The potential for release to all environmental media is low. The unit underwent RCRA-closure after managing hazardous waste. However, the waste currently managed at this unit may be improperly characterized.

Recommendations: PRC recommends no further corrective action for this SWMU at this time. PRC recommends that EPA request a proper waste analysis of the waste paint sludge which is managed as nonhazardous.

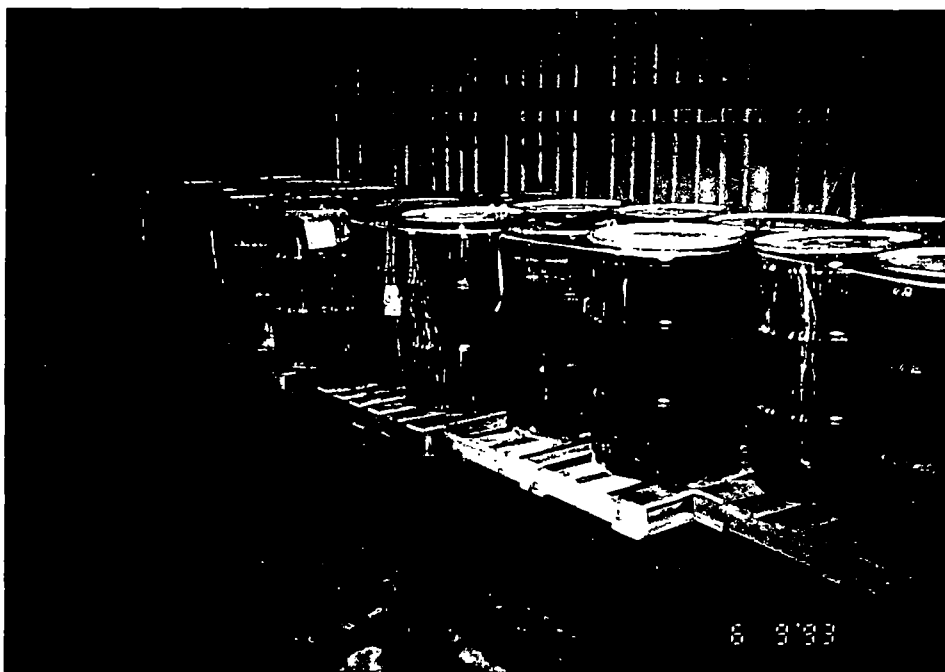
Photograph No. 2

Location: SWMU 1

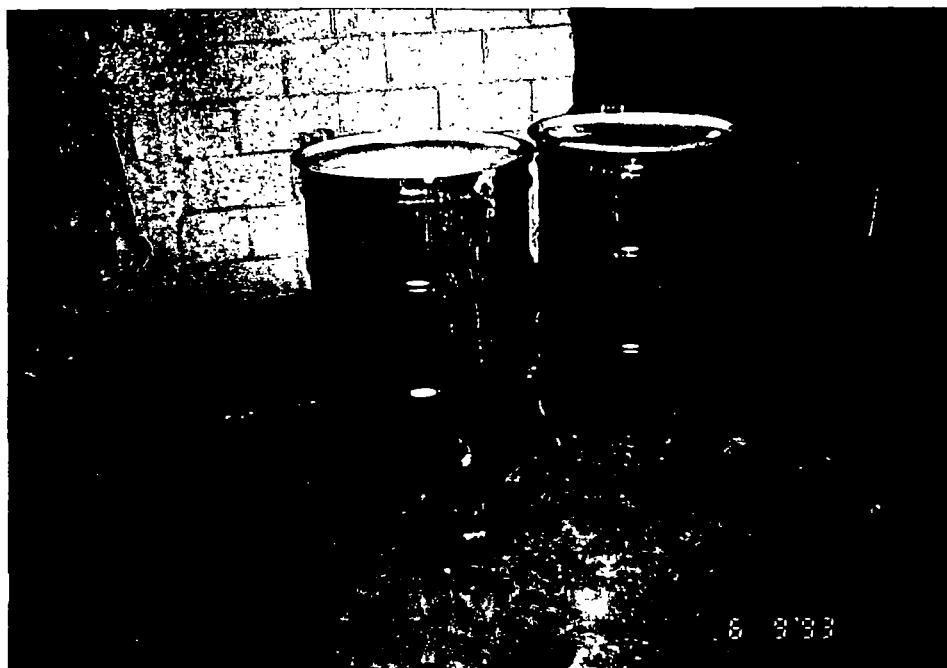
Photograph No. 4

Observations: The unit contained a total of nine partially filled 5-gallon pails and two 55-gallon drums of waste paint and waste solvent throughout the four areas. PRC observed some paint stains on the walls near the pails. The pails were maintained on cardboard. PRC did not observe any cracks in the floor. The containers were stored closed and were in good condition; however, paint stains were visible on the outside of the containers (see Photograph Nos. 3 and 4). PRC noted no evidence of release.

Location: SWMU 2

Conclusions: This unit is located indoors and manages waste paint and waste solvent in 5-gallon pails and 55-gallon drums. These wastes are managed as nonhazardous waste. The potential for release to all environmental media is low because the unit is located indoors, on concrete, in containers which are stored closed and in good condition. The solvent waste may be improperly characterized.

Recommendations: PRC recommends no further corrective action for this SWMU at this time.
PRC recommends that EPA request a proper waste analysis of the waste managed in this SWMU.

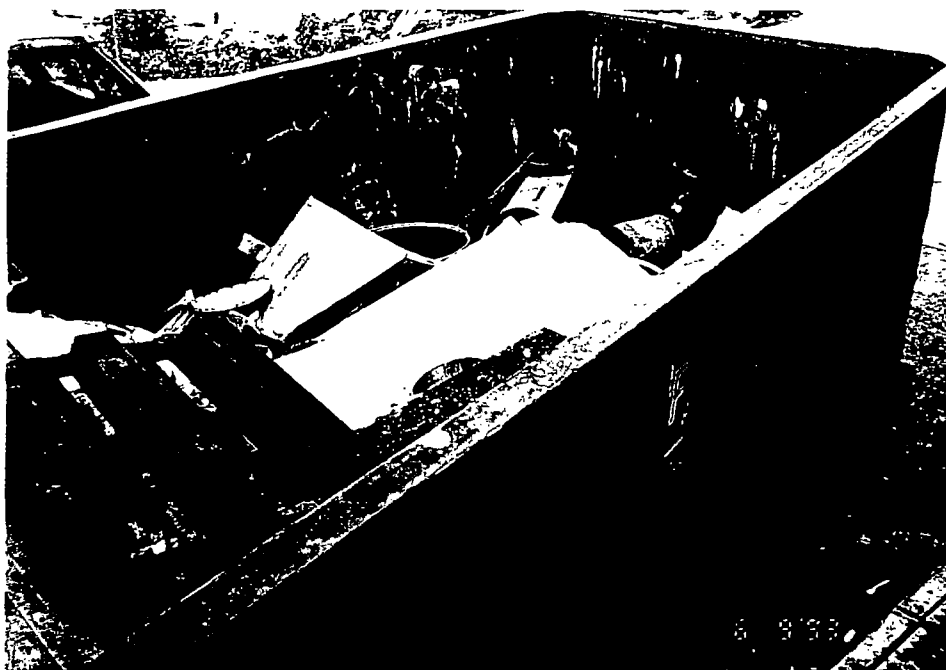
Photograph No. 5

The unit contained general refuse and waste paint filters during the VSI. PRC observed that the dumpster was in good condition (see Photograph No. 5). PRC noted no evidence of release.

Location: SWMU 4

Conclusions: This unit consists of a 20-cubic-yard dumpster located outdoors. The potential for release to groundwater, surface water, and on-site soils is low because the unit manages nonhazardous waste. The potential for release to air is moderate. Baghouse dust placed in this unit may contain hazardous constituents which could become airborne if not contained.

Recommendations: PRC recommends that baghouse dust placed in this unit be contained.

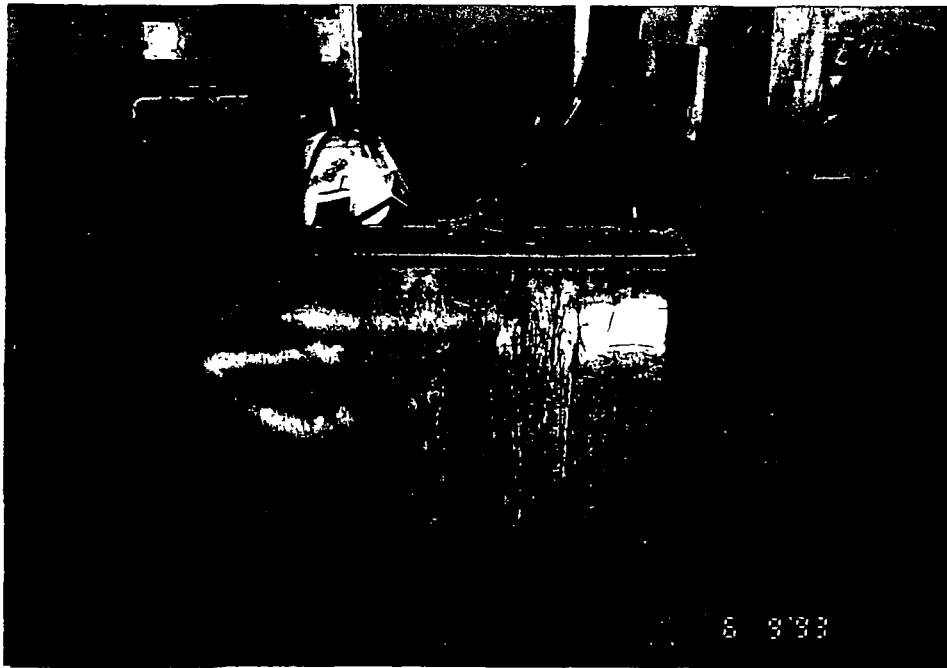
Photograph No. 7

Observations: The unit contained scrap metal during the VSI (see Photograph No. 7). PRC noted no evidence of release.

Location: SWMU 7

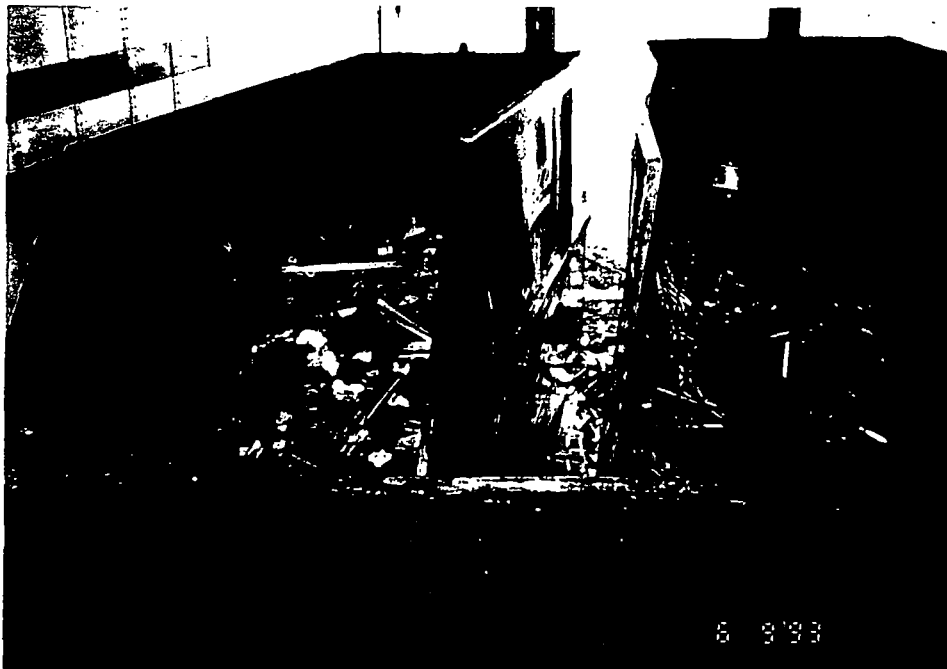
Photograph No. 8

Observations: Both dumpsters were approximately half full during the VSI (see Photograph No. 8). PRC noted no evidence of release.

Location: SWMU 8

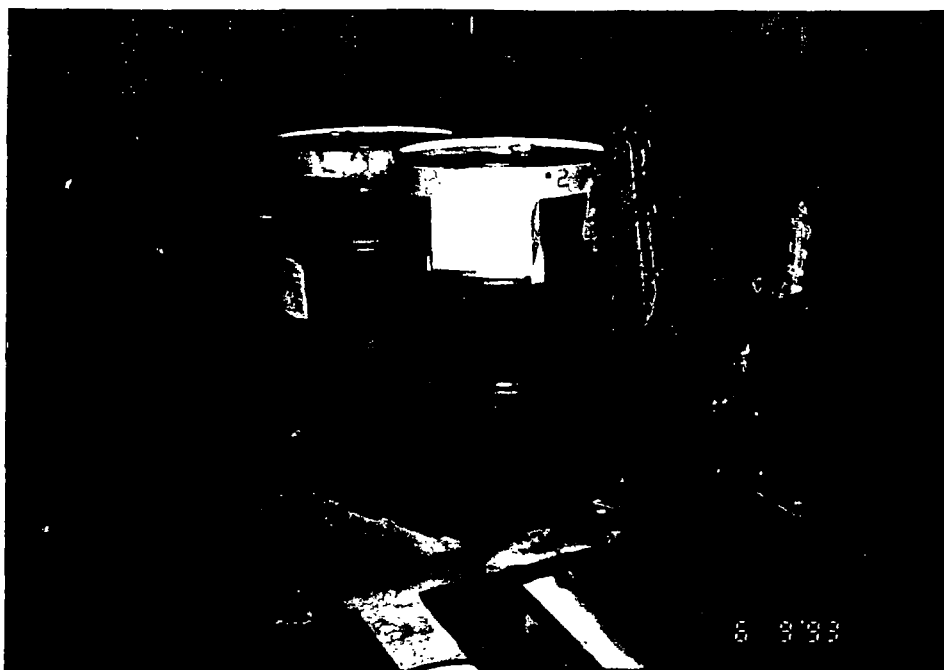
Photograph No. 9

Location: SWMU 9

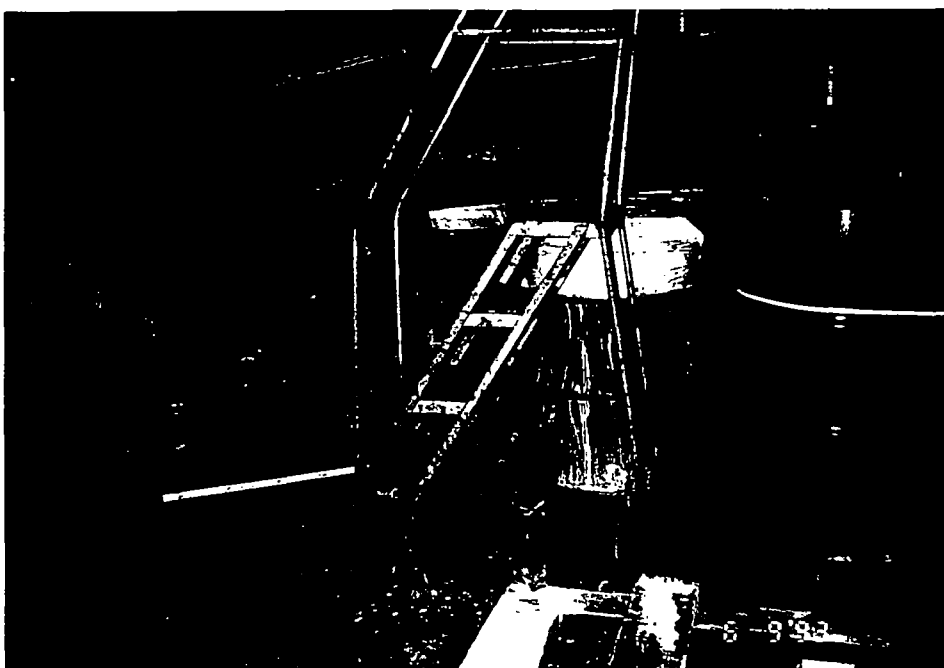
Photograph No. 10

Location: SWMU 9

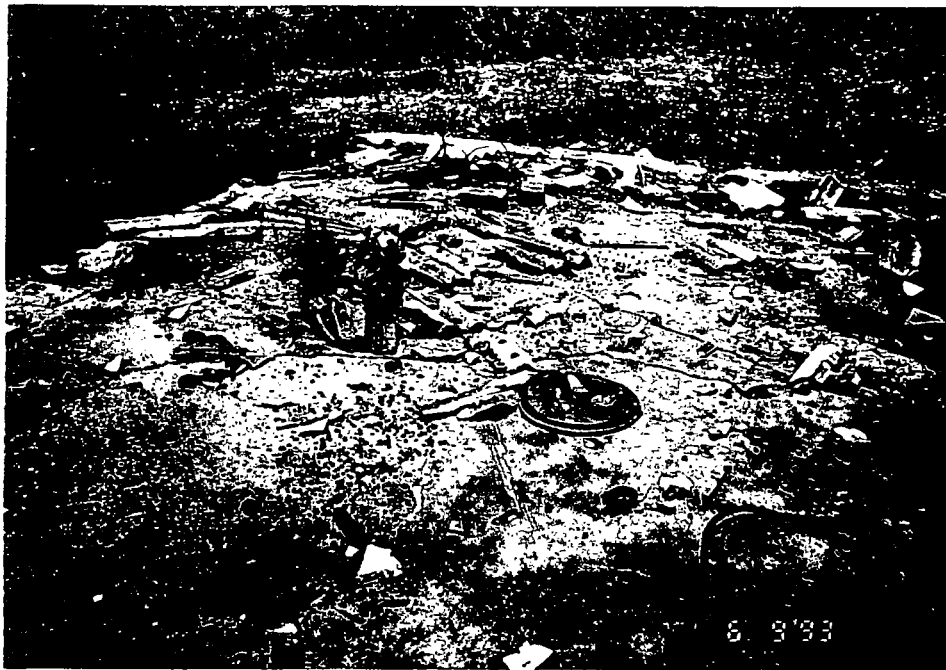
Photograph No. 11

Observations: The unit contained some scrap metal debris during the VSI (see Photograph No. 11). PRC noted no evidence of release.

Description: A Former Incinerator (SWMU 10) was located on this concrete pad before 1972.

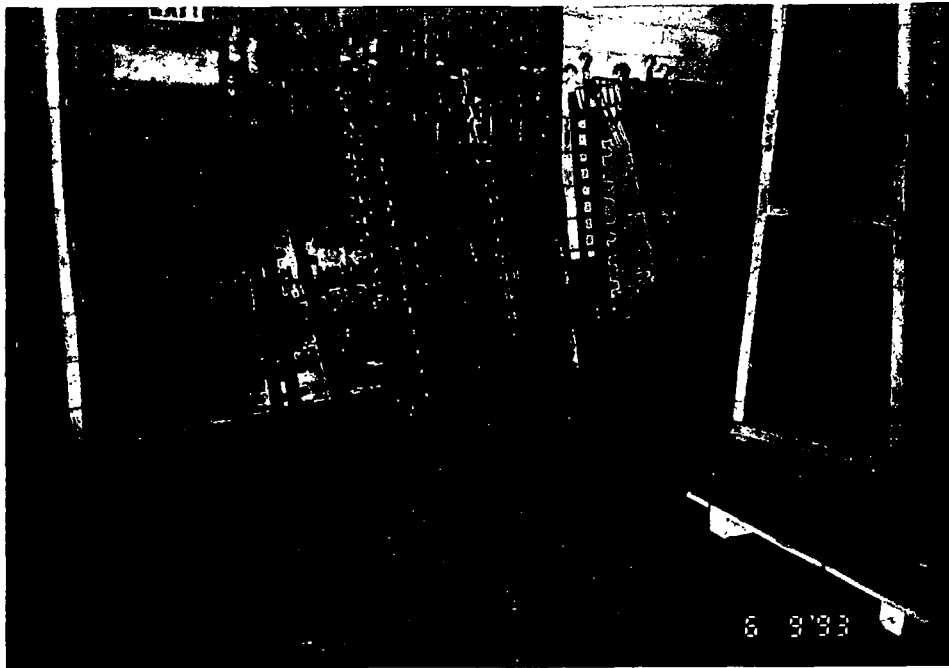
Photograph No. 13

The unit did not exist at the time of the VSI. PRC noted no evidence of release (see Photograph No. 13).

Location: SWMU 12

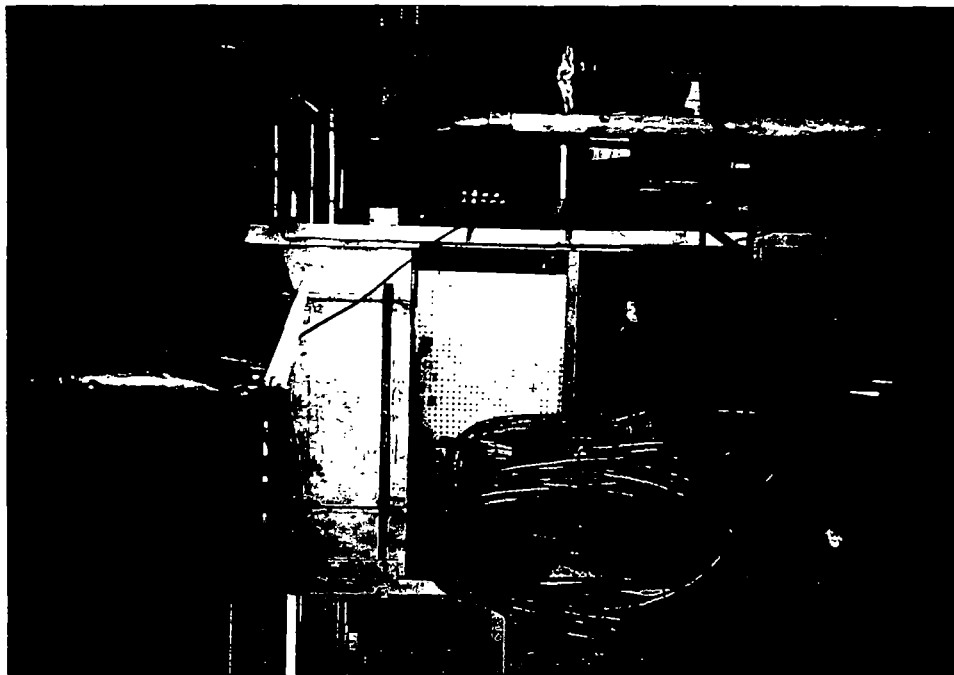
Photograph No. 14

The unit was in operation at the time of the VSI. Three of the baghouses were maintained on concrete which had no floor drains (see Photograph No. 14). PRC noted no evidence of release.
